Buckton Castle Water Treatment Works

NORTH West Water's £10-million Buckton Castle water treatment works at Mossley near Manchester and commissioned this year, is the most modern plant in the region.

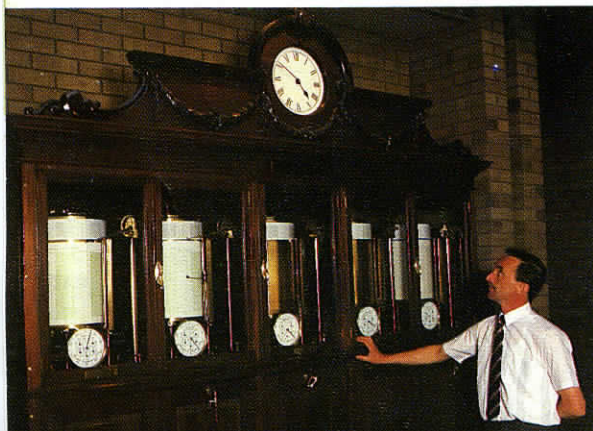
Left: Flow meters from Brushes on display in the foyer.

There is a modern *laboratory* for monitoring the water treatment process. On display in the *foyer* are clarity bowls showing raw, partially treated and fully treated water. And as a reminder of the old treatment works when everything from winding meters to turning hundreds of valves was done manually rather than at the touch of a button, the flowmeters from Brushes waterworks have been refurbished and now stand proudly as an exhibition display.
